VISUAL INSPECTION REPORT CLIENT # 2413

Date and Time of Visual Inspection:	3/23, 2024 @ 10 AM
Lead Dust Sampling	JERRY EHRLICH, Tech# D-I-18846-23-00082
Technician: Client Name:	Jane Doe
Cell / Email:	21 5 555 1212 / NoEmail@Gmail.com
Property Address: Number of Bedrooms:	40271 Main Street Unit 1 Phila Pa 19123 1

EXTERIOR FACADE OF SUBJECT PROPERTY: (40271 Main Street UNIT 1 Phila Pa 19123)

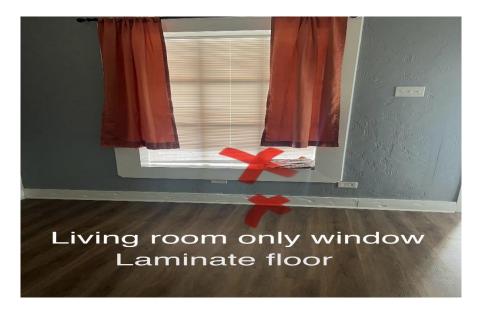
Living Room – ONLY Window & CENTER Floor

One dust wipe sample was collected from this Wooden windowsill and one dust wipe sample was collected from the Laminate floor area directly below this windowsill.

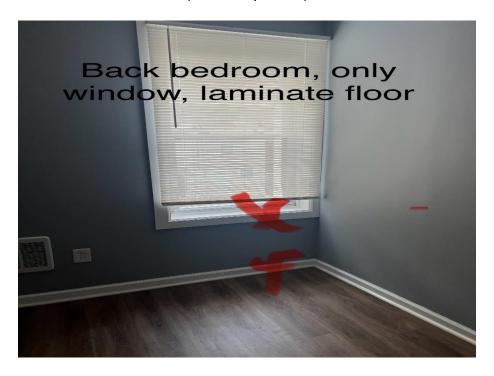
Back Bedroom – ONLY Window & CENTER Floor

One dust wipe sample was collected from this Wooden windowsill and one dust wipe sample was collected from the Laminate floor area directly below this windowsill.
